Operation UPSHOT-KNOTHOLE

March - June 1953

Project 3.5

TESTS ON THE RESPONSE OF WALL AND ROOF
PANELS AND THE TRANSMISSION OF LOAD
TO SUPPORTING STRUCTURE

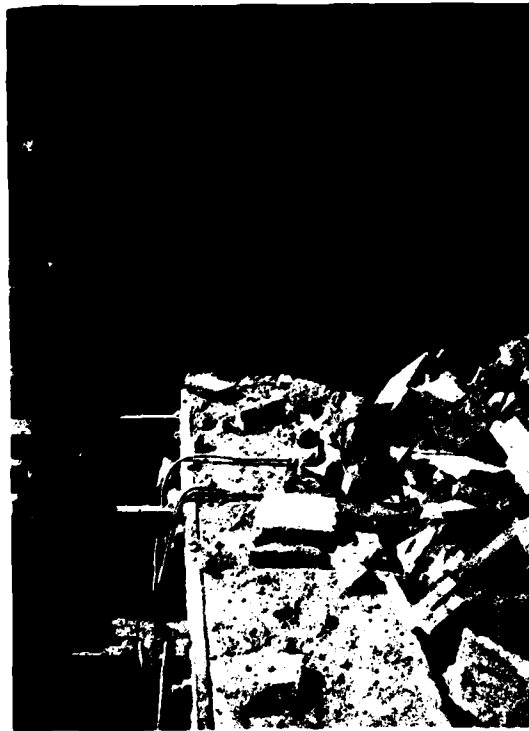
Fig. 4.13 Postshot, 3.5bd, Edge Blocks Showing
Crushing Failure

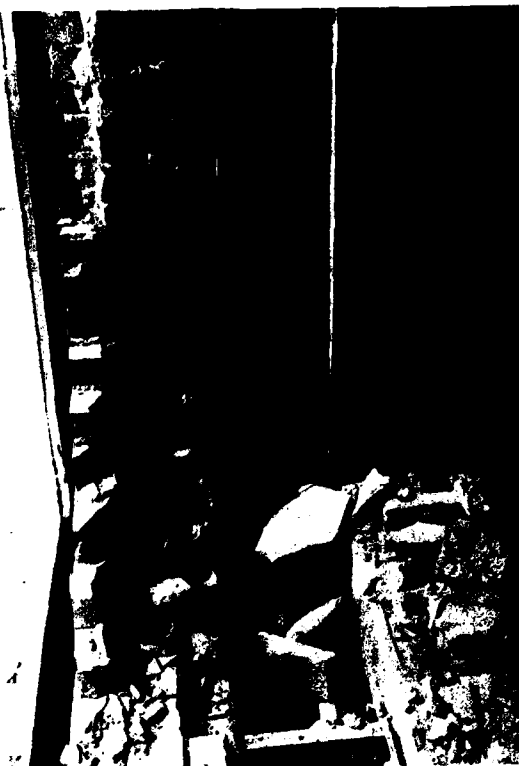
Fig. 4.15 Postshot, 3.5cc, Edge Brick and Block Showing Crushing Failure

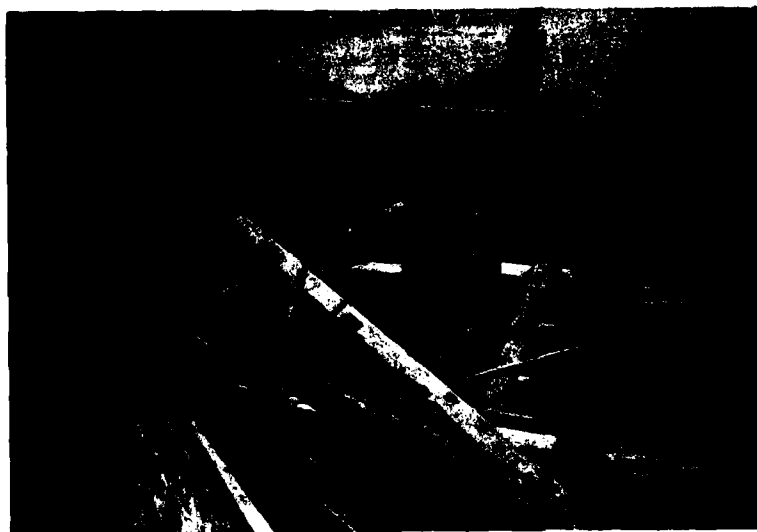
Fig. 4.22 Postshot, 3.5ba, Damaged Bowstring Trusses (Note certain trusses remained intact)

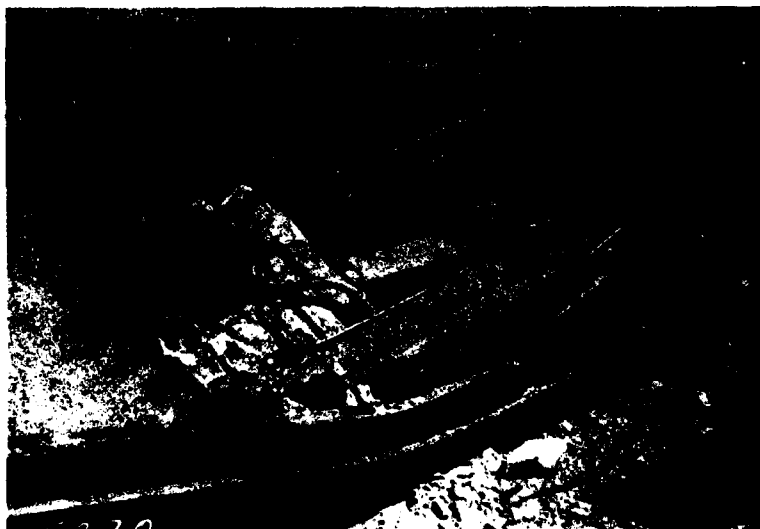
Fig. 4.30 Postshot, 3.5cb, Damage to Steel
Channel Roof Beams
